## **Windstorm Mitigation Report (OIR-B1-1802)**

Parkwood Square Villas Condominium

5875 37th Ave N, Units 1-8

As of 5/24/2022 | FPAT File# MUD2216962

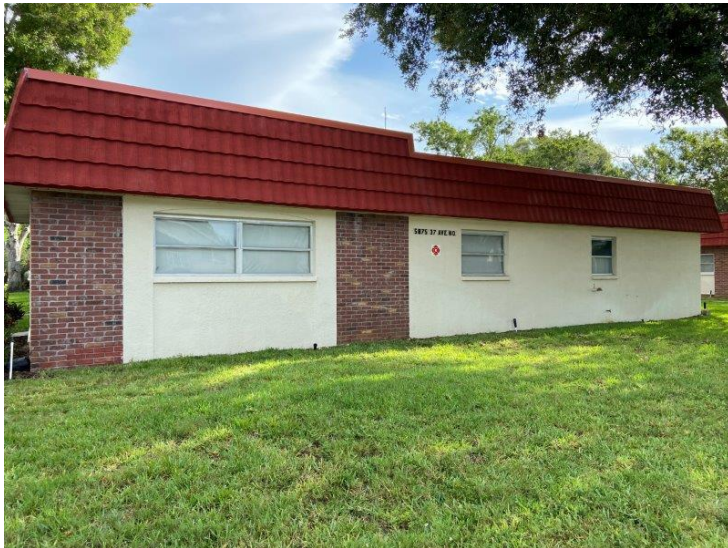
Exterior Elevation

- 5. Roof Geometry:** **Flat Roof**  
Comments: Inspection verified flat roof shape, refer to attached photographs.
- 6. SWR:** **No**  
Comments: SWR does not apply to metal bar joists with lightweight concrete panels.

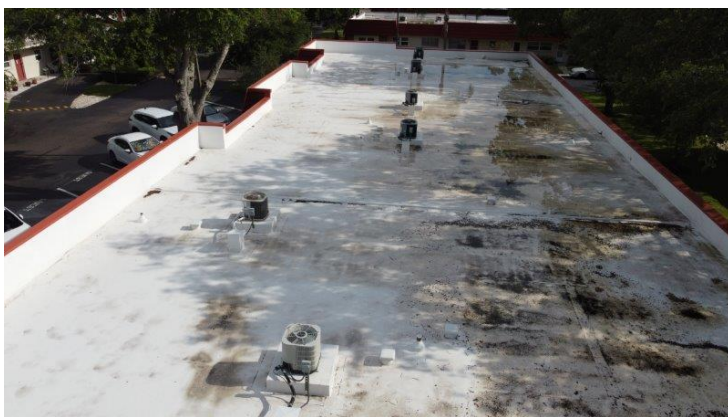
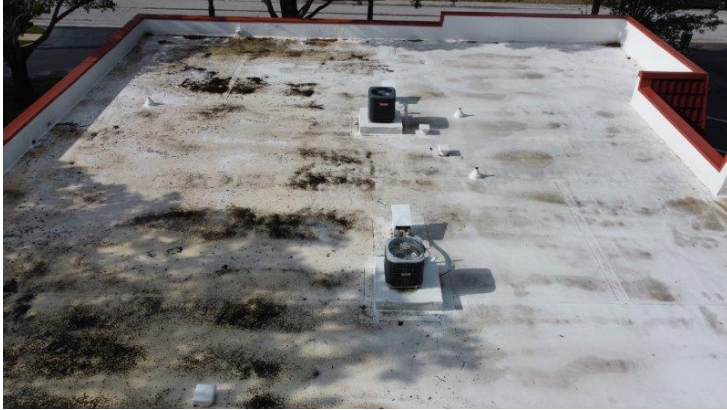
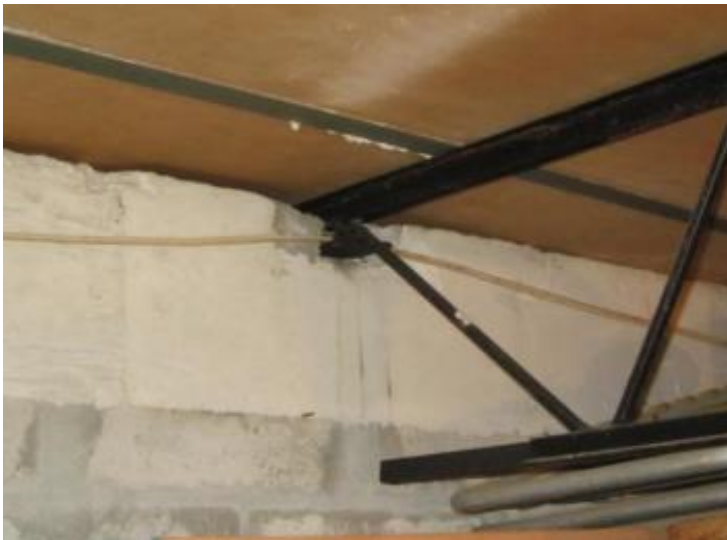
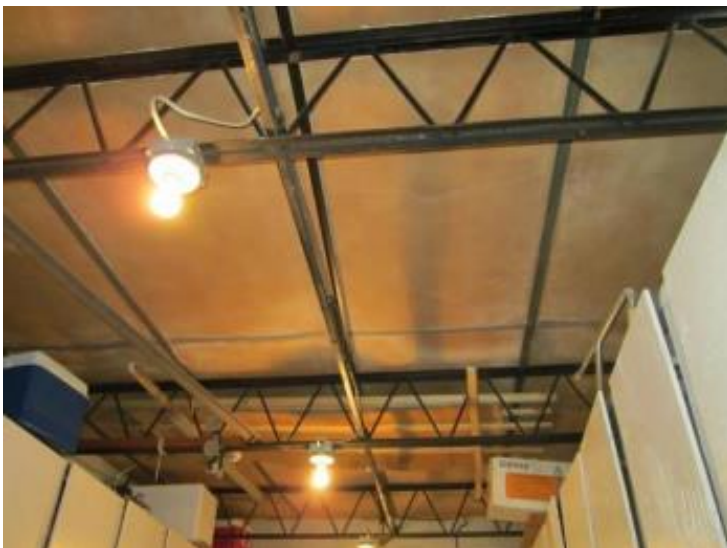
Roof Construction

- 3. Roof Deck Attachment:** **Other**  
Comments: Inspection verified a roof deck composed of lightweight concrete gypsum panels supported by steel bar joists.

- 4. Roof to Wall Attachment:** **Structural**  
Comments: Inspection verified a roof-wall connection composed of steel bar joists structurally connected to the wall/support system.
