Windstorm Mitigation Report (OIR-B1-1802)

Parkwood Square Villas Condominium

5865 37th Ave N, Units 19-27

As of 5/24/2022 | FPAT File# MUD2216962

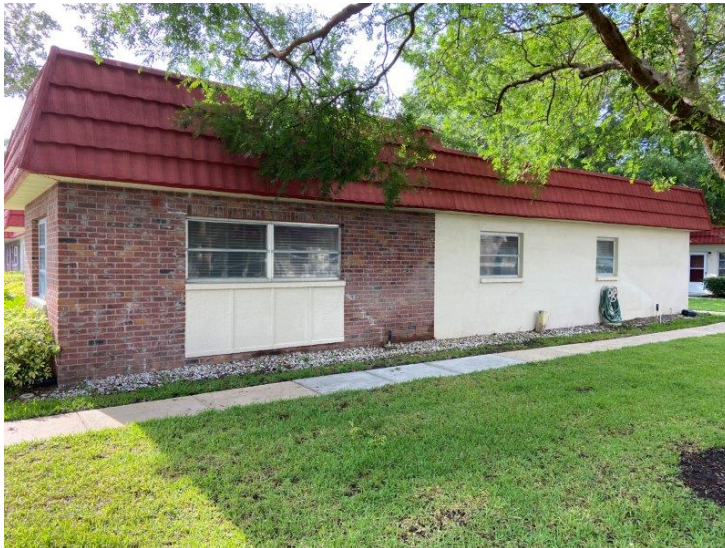
Exterior Elevation

- 5. Roof Geometry:**
Comments: **Flat Roof**
Inspection verified flat roof shape, refer to attached photographs.
- 6. SWR:**
Comments: **No**
SWR does not apply to metal bar joists with lightweight concrete panels.

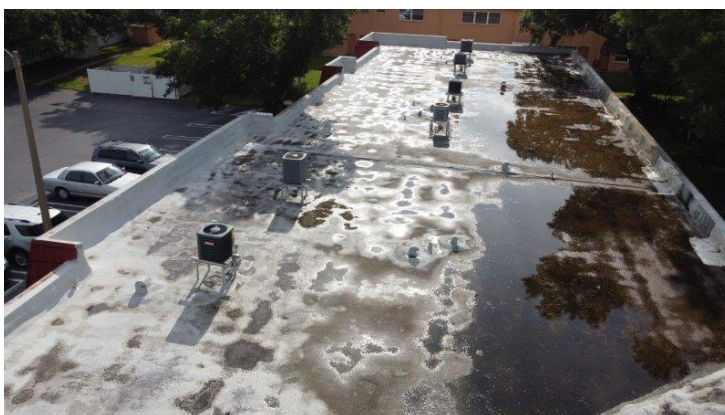
Roof Construction

- 3. Roof Deck Attachment:**
Comments: **Other**
Inspection verified a roof deck composed of lightweight concrete gypsum panels supported by steel bar joists.

- 4. Roof to Wall Attachment:**
Comments: **Structural**
Inspection verified a roof-wall connection composed of steel bar joists structurally connected to the wall/support system.
