Windstorm Mitigation Report (OIR-B1-1802)

Parkwood Square Villas Condominium

5860 38th Ave N, Units 28-36

As of 5/24/2022 | FPAT File# MUD2216962

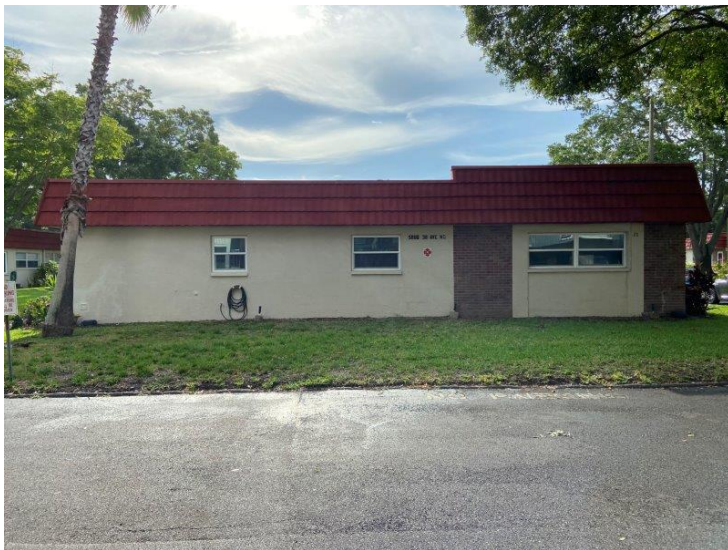
Exterior Elevation

- 5. Roof Geometry:** **Flat Roof**
Comments: Inspection verified flat roof shape, refer to attached photographs.
- 6. SWR:** **No**
Comments: SWR does not apply to metal bar joists with lightweight concrete panels.

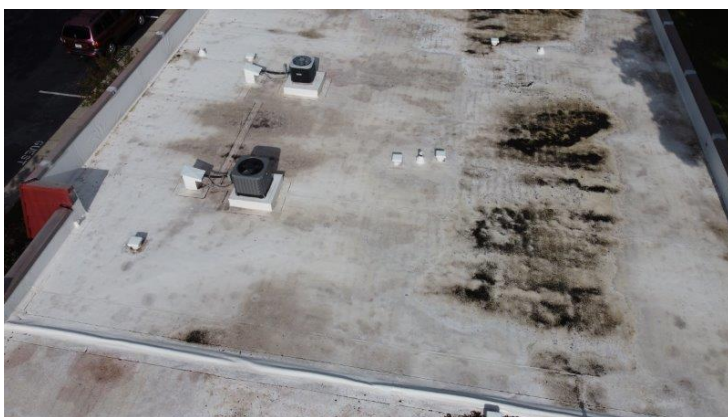
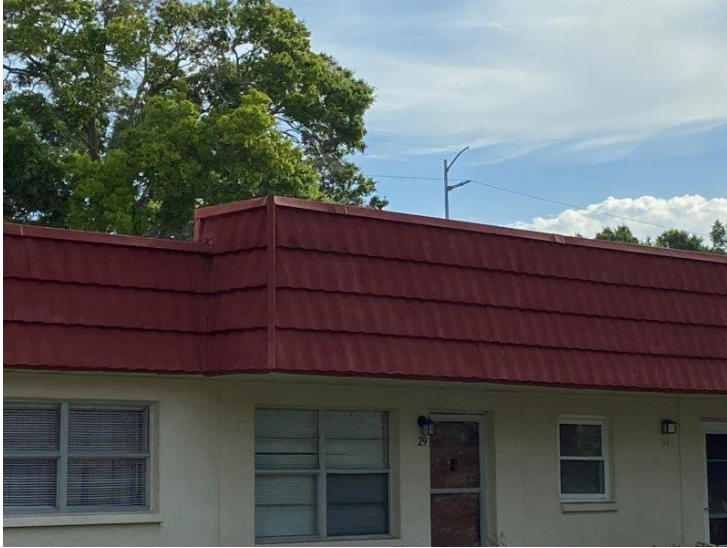
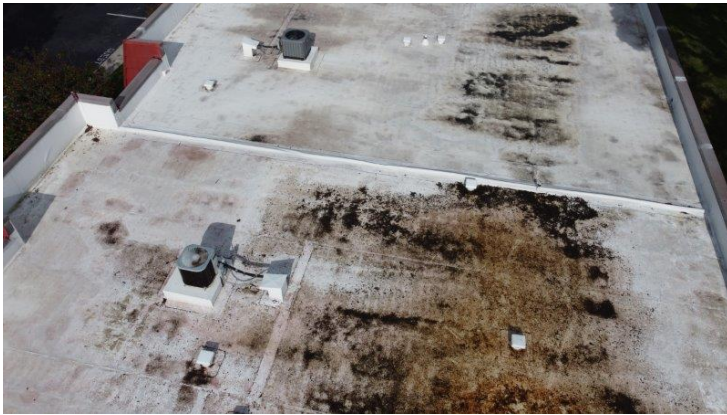
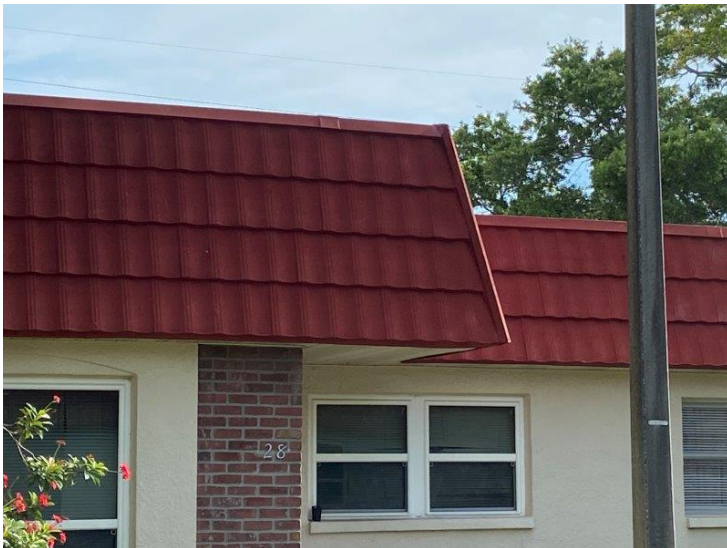
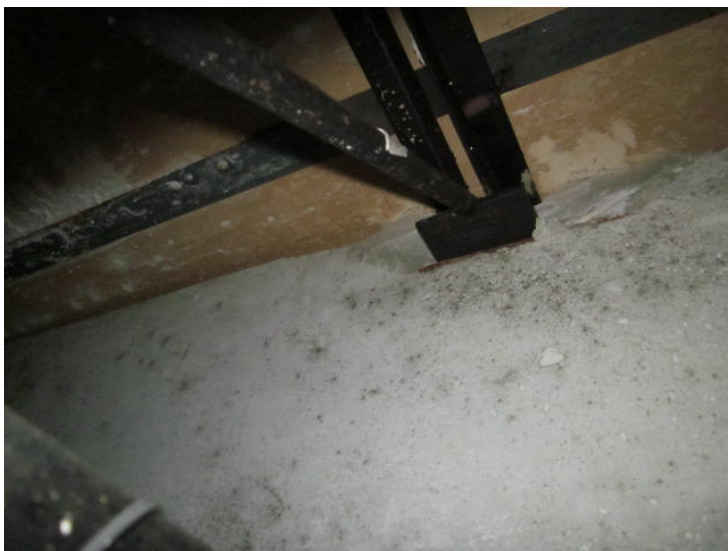
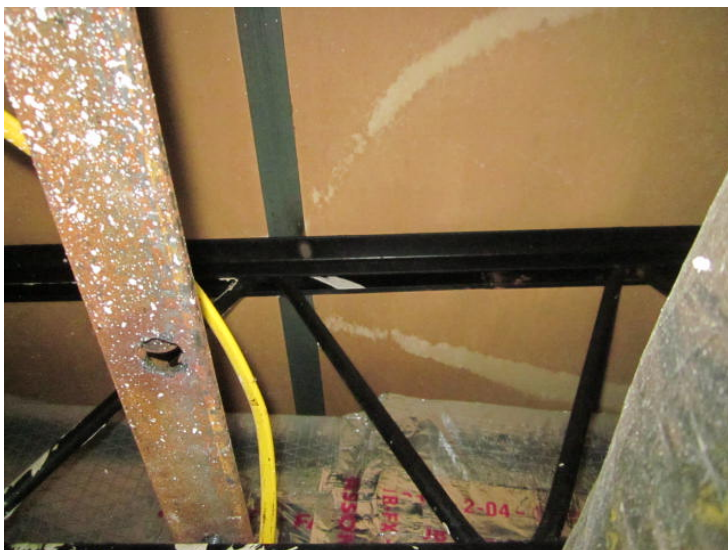
Roof Construction

- 3. Roof Deck Attachment:** **Other**
Comments: Inspection verified a roof deck composed of lightweight concrete gypsum panels supported by steel bar joists.

- 4. Roof to Wall Attachment:** **Structural**
Comments: Inspection verified a roof-wall connection composed of steel bar joists structurally connected to the wall/support system.
