## Windstorm Mitigation Report (OIR-B1-1802)

Parkwood Square Villas Condominium

5870 38th Ave N, Units 37-45

As of 5/24/2022 | FPAT File# MUD2216962

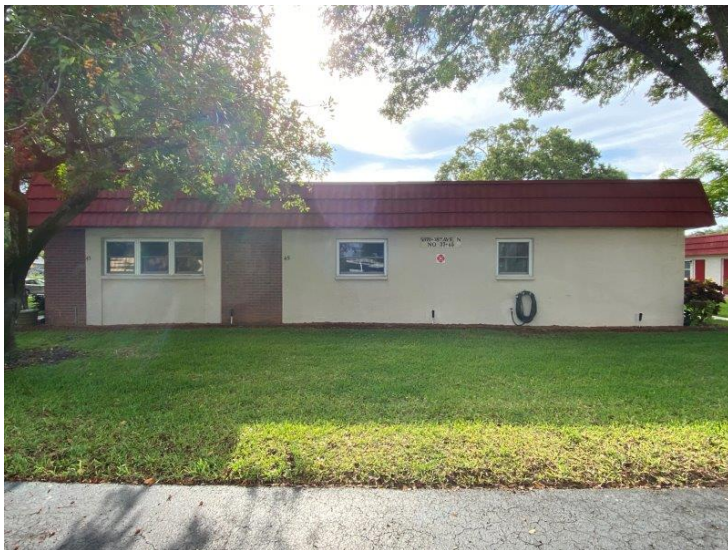
Exterior Elevation

- 5. Roof Geometry:** **Flat Roof**  
Comments: Inspection verified flat roof shape, refer to attached photographs.
- 6. SWR:** **No**  
Comments: SWR does not apply to metal bar joists with lightweight concrete panels.

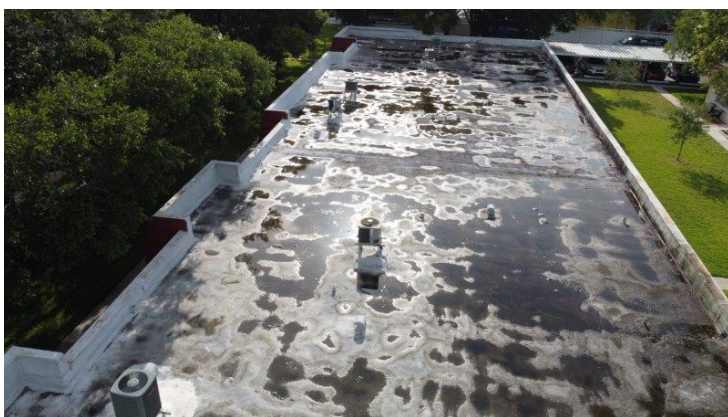
Roof Construction

- 3. Roof Deck Attachment:** **Other**  
Comments: Inspection verified a roof deck composed of lightweight concrete gypsum panels supported by steel bar joists.

- 4. Roof to Wall Attachment:** **Structural**  
Comments: Inspection verified a roof-wall connection composed of steel bar joists structurally connected to the wall/support system.
