## Windstorm Mitigation Report (OIR-B1-1802)

Parkwood Square Villas Condominium

5845 37th Ave N, Units 9-18

As of 5/24/2022 | FPAT File# MUD2216962

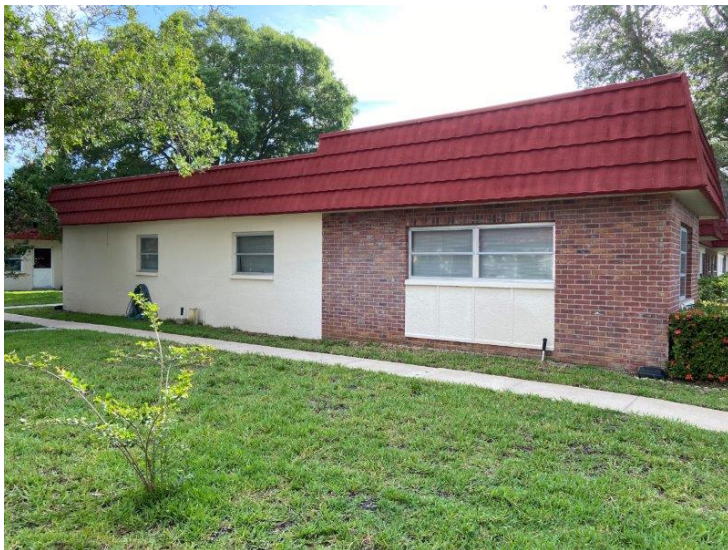
Exterior Elevation

- 5. Roof Geometry:** **Flat Roof**  
Comments: Inspection verified flat roof shape, refer to attached photographs.
- 6. SWR:** **No**  
Comments: SWR does not apply to metal bar joists with lightweight concrete panels.

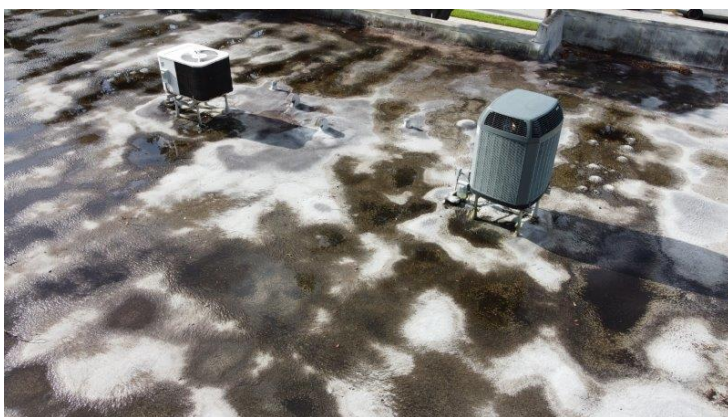
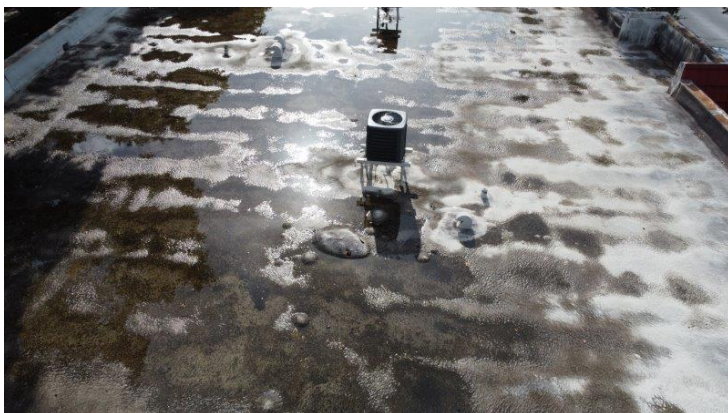
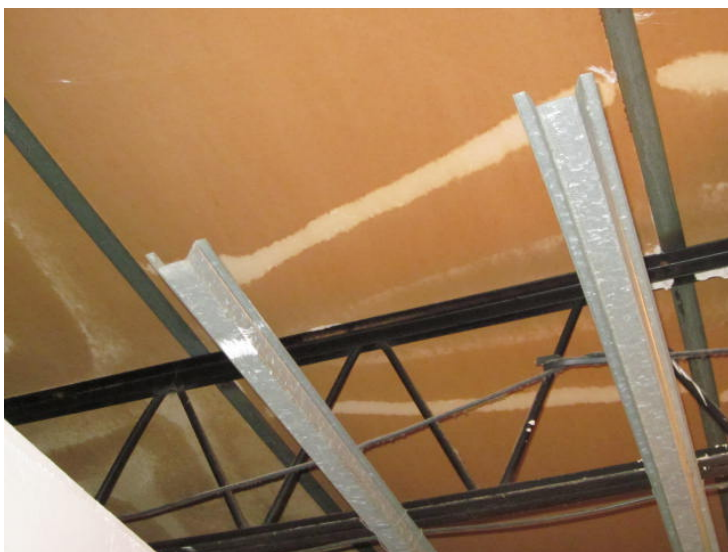
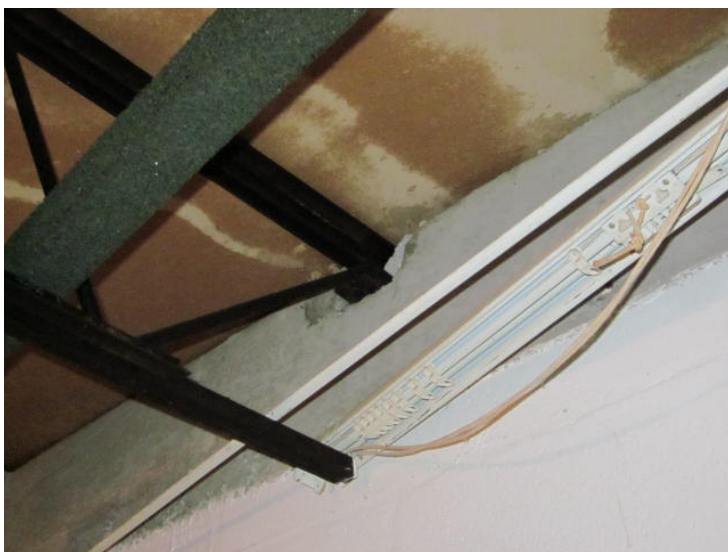
Roof Construction

- 3. Roof Deck Attachment:** **Other**  
Comments: Inspection verified a roof deck composed of lightweight concrete gypsum panels supported by steel bar joists.

- 4. Roof to Wall Attachment:** **Structural**  
Comments: Inspection verified a roof-wall connection composed of steel bar joists structurally connected to the wall/support system.
